Manhole Inspection Summary

Manhole # S17EE2028MH

Insp Date: **8/3/06 9:35 AM**

Location Address: **1819 SULGRAVE AVE**

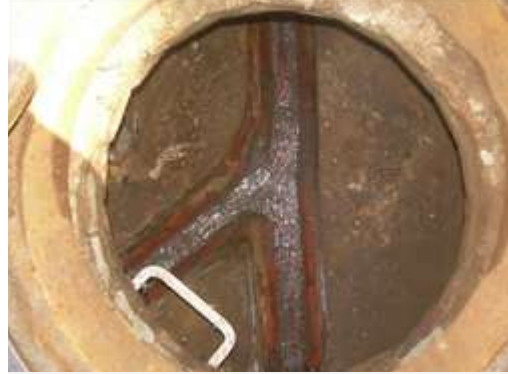
Top View

Evidence of surcharge - Bench debris.

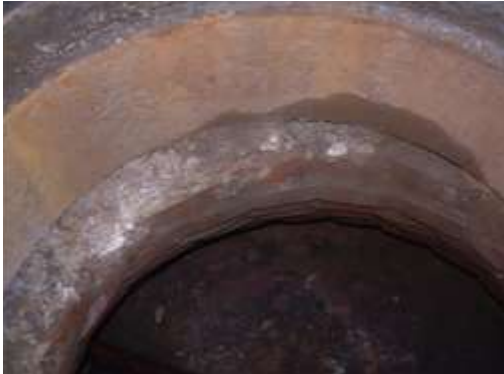
Defect

Frame leaks. Frame offset. Corbel deterioration and infiltration. Barrel infiltration.

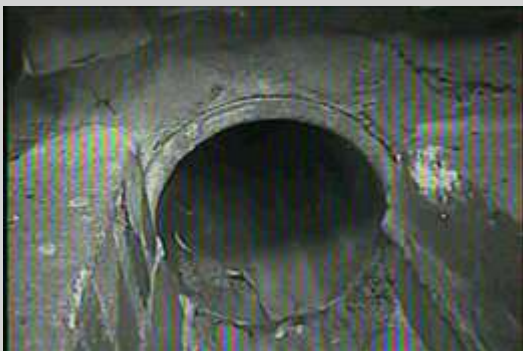
8 in. Circular Gravity Sewer Pipe In @ 6 O'Clock

Cracked pipe.

Infiltration: **Evidence** Pipe Seal Cond: **Cracked**

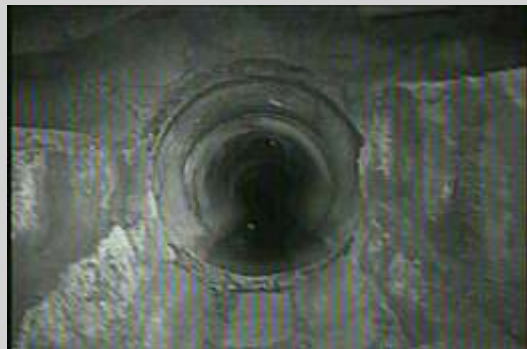
8 in. Circular Gravity Sewer

Infiltration: **Evidence**

Pipe Seal Cond: **Cracked**
